GENERATOR TROUBLESHOOTING AND REPAIR

A crude oil tanker built in 2008 with 228m overall length and 32m beam, and a gross tonnage of 41676t, experienced a winding failure on a Main Alternator.

Maker: Taiyo Electric Co.
850kVA, 1091A, 8 poles / 900 rpm, 450V, 60Hz.

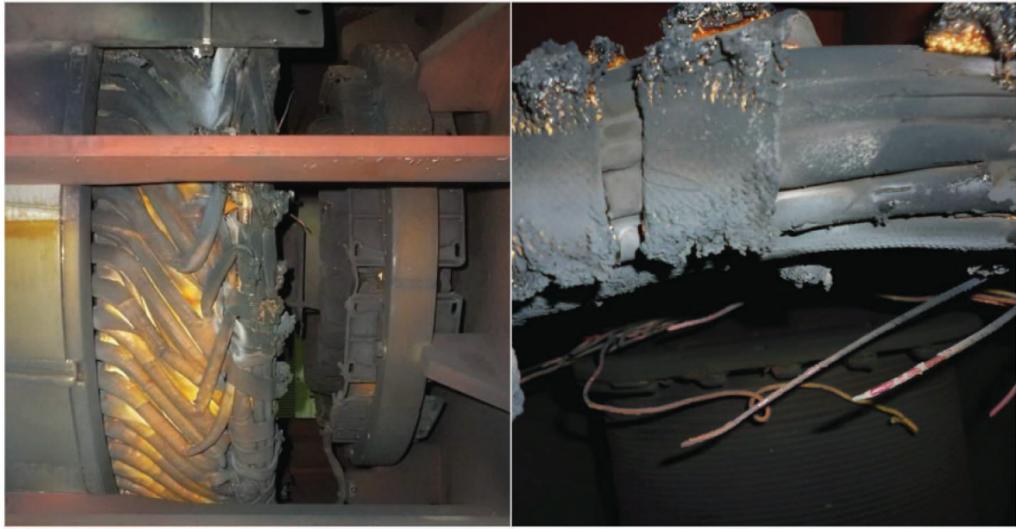
Initially, a visual assessment identified stator lamination damage affected by winding failure inside the slots. The Rotor and Exciter were showing a low insulation condition. This guided METALOCK to believe that the stator core was damaged and therefore renewal of the core or other possible repairs were necessary, but, adequate core testing would have to be done and the equipment totally dismantled in METALOCK's workshop.

- Rotor and Exciter (rotor and stator): Resistance measurements of coils (separately and connected), surge tests, loop tests and analysis of the Exciter Rotor.
- Rotor shaft trueness run out check.
- NDE Bearing seat was found to be worn.
- Stator winding : Loop test and measurements.

Due to high temperature findings with the presence of various hot spots, it was decided to change the core and not reshuffle the laminations or effect any repair attempt.

The damaged Bearing Case was repaired at a third party workshop in Brazil by thermal aspersation process, including pre-machining, rectification and final polishing of the repaired surface. A new bearing was supplied by the client.

The new stator core was assembled in the Generator frame and the rewinding was done by METALOCK as follows, to guarantee a high quality traceable winding:

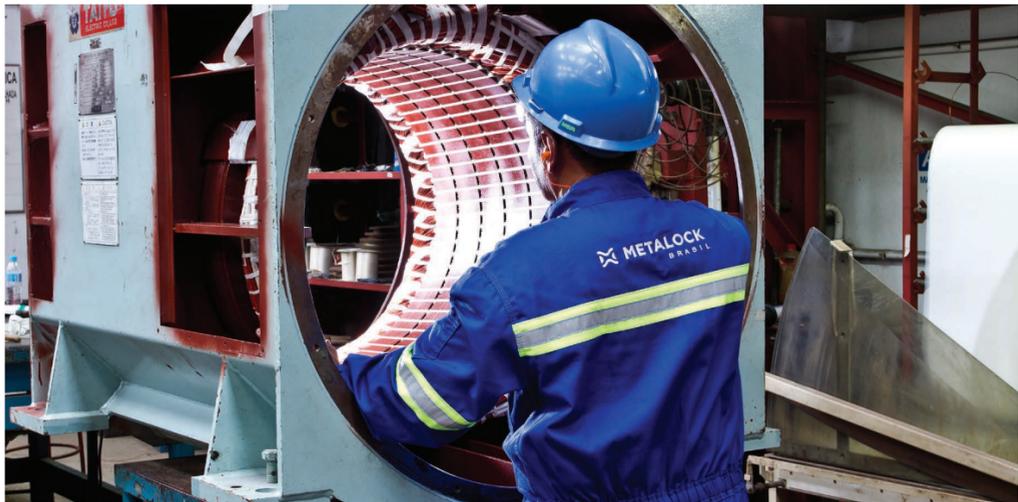
Practical testing of generator after its repair completion at METALOCK BRASIL was arranged at a third party electrical machinery factory in Sao Paulo, Brazil. Metalock developed and produced a dummy cover at DE side to emulate the generator's real condition, thus enabling full running test. A short-circuit, temperature raise and partial load test were carried out in the presence of the client's representative. Full test reports were recorded, which proved to be in line with original testing performed to alternator type approval by ABS with Taiyo, prior delivery of vessel at shipyard, during her construction.

The generator was tested at nominal rpm, at no-load, short circuit and 233.8 KVA inductive load, also the output voltage has been checked with the generator self-excited. After the workshop test the generator has been returned to METALOCK for dismantling and preparation, to be returned to the vessel. The Stator and the Rotor were separated and packed in two wooden boxes.
