## ELECTRICAL AND VIBRATIONAL ANALYSIS OF A THRUSTER ELECTRIC MOTOR

**CMM GRAVITY**

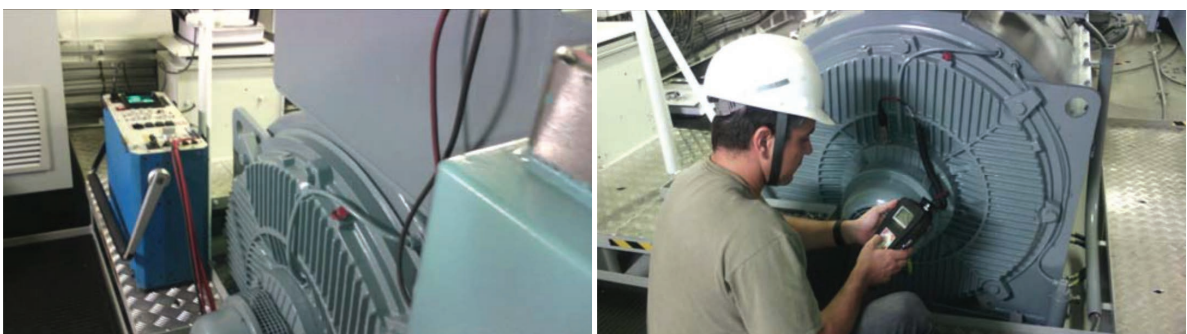
The following analysis and checks were executed: Full offline dielectric analysis of winding condition using SKF / Baker motor analyser:

- Insulation resistance to ground;
- Phase sequence and surge analysis of all 3 phases;
- Polarization and absorption indexes (PI and DAR);
- Ohmic resistance comparison check between phases and Delta R.

After the electrical analysis, the electric motor was found to be in good order. Abnormal noise frequency was identified as coming from the NDE Bearing, indicating damage of the same.

The client received the recommendation for urgent action to prepare and effect the bearing's replacement.
