MECHANICAL MARINE DIESEL ENGINE REPAIR: PORT SIDE MAIN ENGINE & REDUCTION GEAR

The ship is a Platform Supply Vessel built in 1999 with two Caterpillar 3606 main engines (4640BHP; LOA 66m; DWT 2800mt). The vessel is classified by ABS.

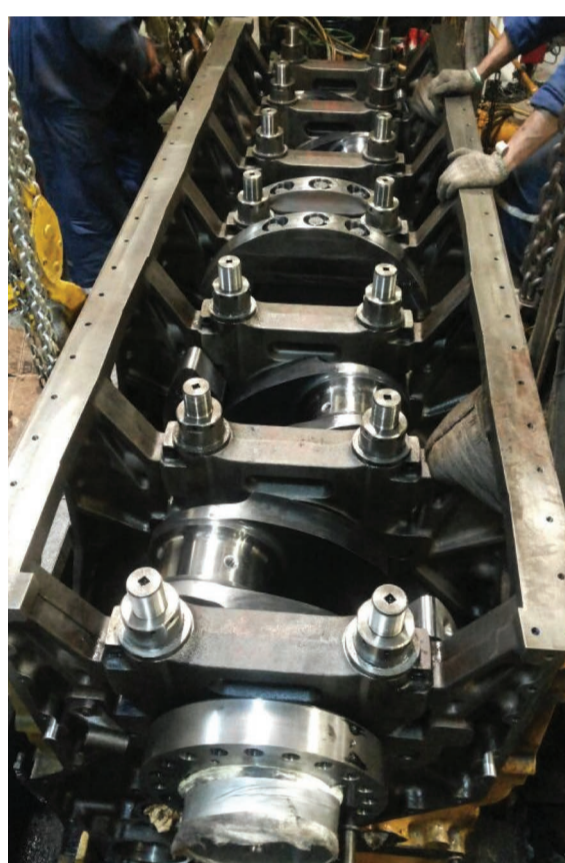
Metalock Brasil Ltda. was contracted to prepare portable equipment and to attend on board the vessel at Rio de Janeiro anchorage with specialist In Situ Machining, mechanical and alignment Service Teams to carry out inspections and necessary repair services on Port Side Main Engine:

1. Inspect main journal pockets, including all dimensional checks before and after line boring, according to the maker's tolerance tables. Having found scratches and white metal deposited on crankpins and main' journals, the crankshaft was dismantled and measurements taken. Crankpin diameter measurements varied from 214,97mm to 215,98mm. Hardness measurements varied from 45,4 HS to 73,8 HS. Main Bearing pockets before machining varied between 264,80mm and 265,08mm. Two Main Bearing Pockets were machined with Metalock's Line Boring Machine and measured at 265,98mm. Having established the amount of material to be removed from crankpins, in excess of makers allowance specification, it was decided to scrap the crankshaft and fit a new one. At the client's request, the new crankshaft was inspected and crankpin and main journal dimensional and hardness measurements were taken and reported by Metalock technicians.
